Manhole Inspection Summary

Manhole # S05AA1018MH

Insp Date: **7/2/07 10:08 AM**

Location Address: **3819 CHATAM RD** Cross Street: **AYREDALE AVE**

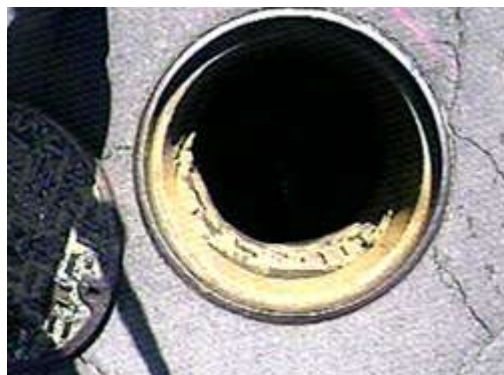
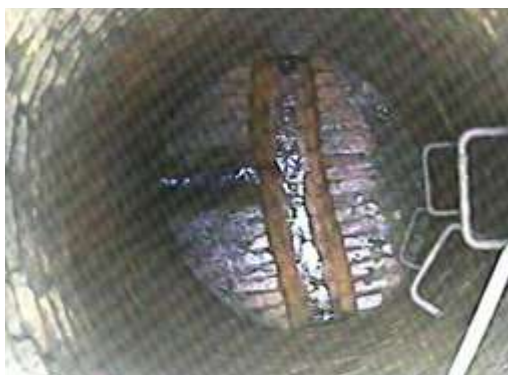
Top View

Cover Shape: **Circular** Diameter: **25.** (in.) Length: (in.) Dist A/B Grade: **0** (in.)
75

Type: **Sanitary** Condition: **Sound** Cover Material: **Cast Iron**

Frame Offset: **0** (in.) Condition: ☒ Sound ☐ Cracked ☐ Leaks

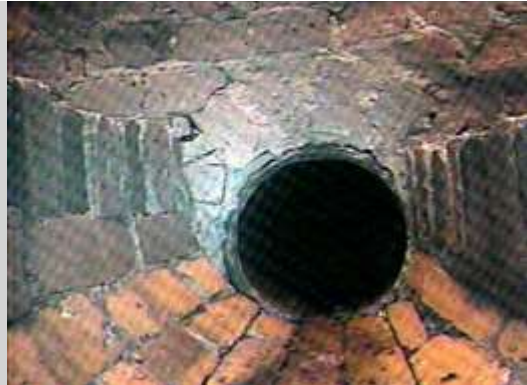
12 O'Clock Outflow

8 in. Circular Gravity Sewer
Pipe Out @ 12 O'Clock

Pipe Height: (in.) Direct
Pipe Material: **Clay** ☐ Pipe Lined
Invert Depth: **9.77** (ft.) Flow Characteristics: **Slow**
Deposits: ☒ None ☐ Mud ☐ Sludge ☐ Debris ☐ Grease
Silt Depth: (in.) Deposits Extent:
Infiltration: **None** Pipe Seal Cond: **Sound**

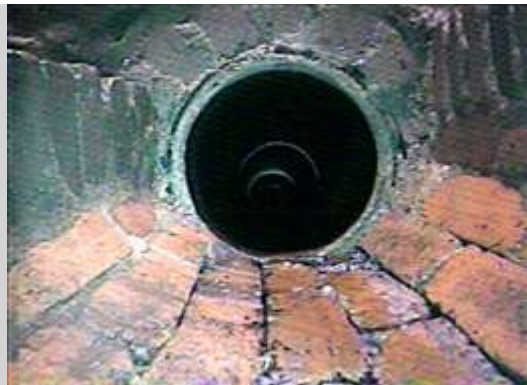
5 O'Clock Inflow

8 in. Circular Gravity Sewer
Pipe In @ 5 O'Clock

Pipe Height: (in.) Direct
Pipe Material: **Clay** ☐ Pipe Lined
Invert Depth: **9.73** (ft.) Flow Characteristics: **Slow**
Deposits: ☒ None ☐ Mud ☐ Sludge ☐ Debris ☐ Grease
Silt Depth: (in.) Deposits Extent:
Infiltration: **None** Pipe Seal Cond: **Sound**

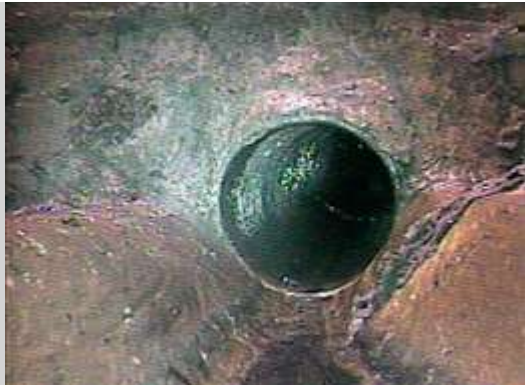
9 O'Clock Inflow

6 in. Circular Gravity Sewer

Pipe In @ 9 O'Clock

Invert Depth: **9.33** (ft.) Flow Characteristics: **Slow**

Infiltration: **None**

Pipe Seal Cond: **Sound**
